**Flood Control Project Maintenance
Levee Inspections
LMA District Cover Sheet
Spring 2010 Levee Inspection Results**

San Joaquin County Flood Control and Water Conservation District

Spring 2010 Levee Inspection Results

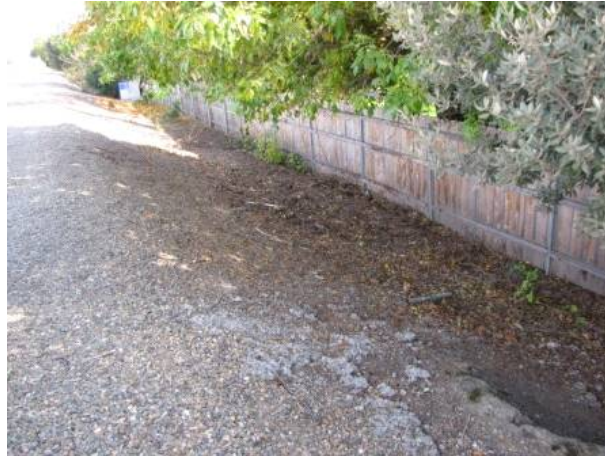
View of a fence along the landward toe looking upstream.

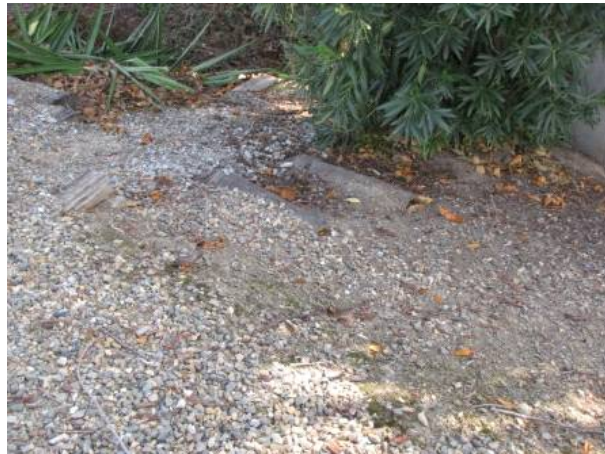
Levee Mile Report Line	82
Start Levee Mile	2.19
End Levee Mile	2.19
Location	Land Side
Category	Earthen Levee
Item	Encroachments

View of steps dug into the landward slope.

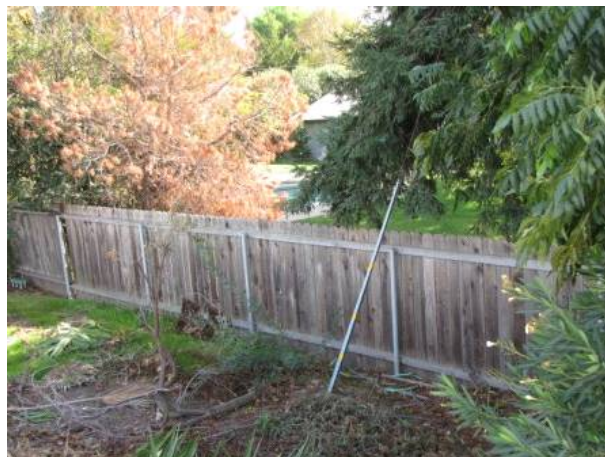
Levee Mile Report Line	83
Start Levee Mile	2.19
End Levee Mile	2.25
Location	Land Side
Category	Earthen Levee
Item	Encroachments

View of a fence along the landward toe.

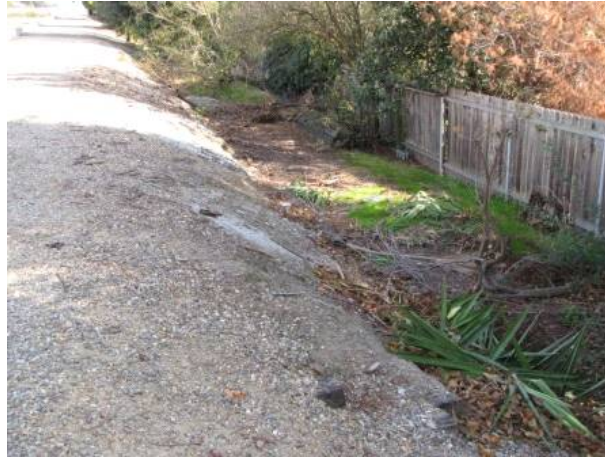
View of prunings on the landward slope and toe looking upstream.

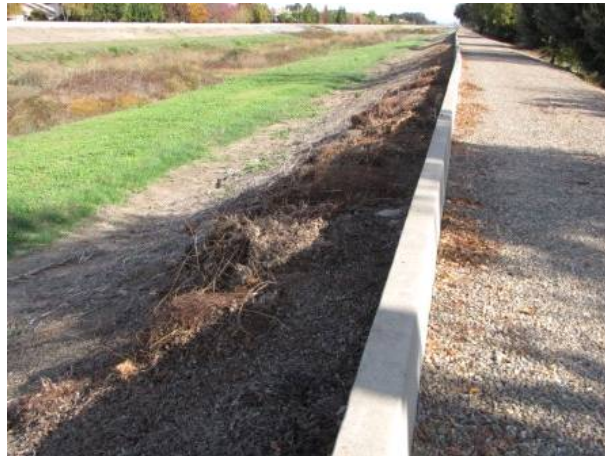
Levee Mile Report Line	85
Start Levee Mile	2.19
End Levee Mile	2.21
Location	Water Side
Category	Earthen Levee
Item	Encroachments

View of prunings on the waterward slope looking upstream.

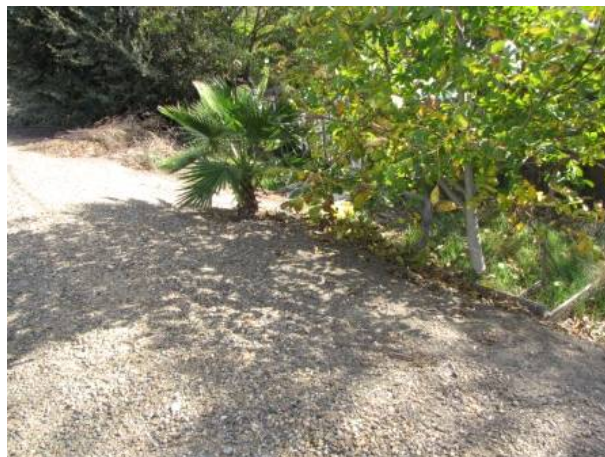
Levee Mile Report Line	86
Start Levee Mile	2.22
End Levee Mile	2.22
Location	Land Side
Category	Earthen Levee
Item	Encroachments

View of landscaping on the landward slope.

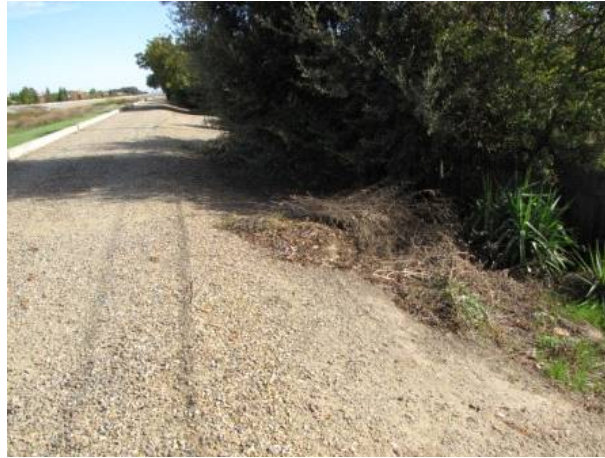
View of prunings on the landward slope looking upstream.

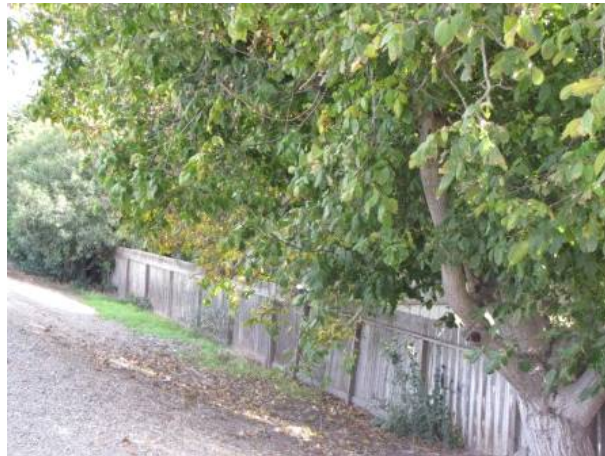
Levee Mile Report Line	88
Start Levee Mile	2.25
End Levee Mile	2.30
Location	Land Side
Category	Earthen Levee
Item	Encroachments

View of a wood fence at the landward toe.

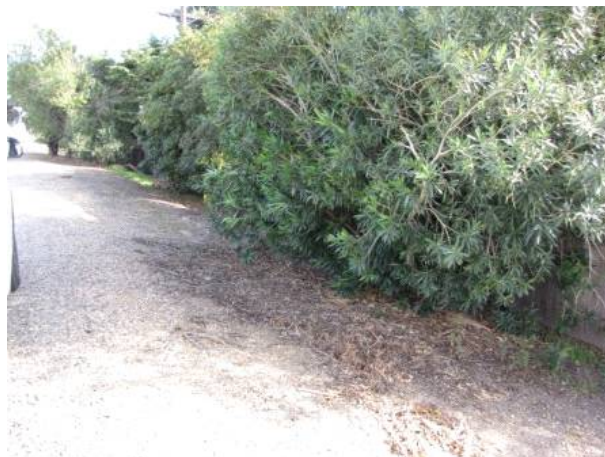
Levee Mile Report Line	89
Start Levee Mile	2.27
End Levee Mile	2.27
Location	Land Side
Category	Earthen Levee
Item	Encroachments

View of landscaping along the landward slope looking upstream.

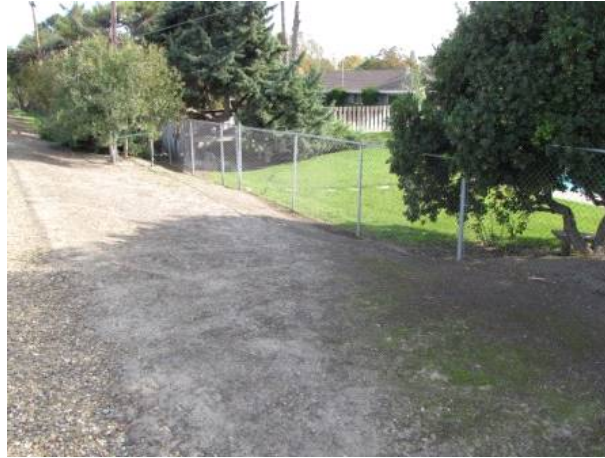
View of a fence on the landward slope looking upstream.

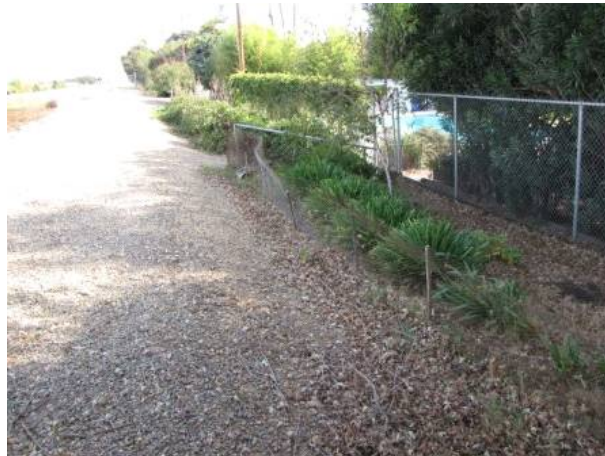
Levee Mile Report Line	91
Start Levee Mile	2.32
End Levee Mile	2.34
Location	Land Side
Category	Earthen Levee
Item	Encroachments

View of landscaping on the landward slope looking upstream.

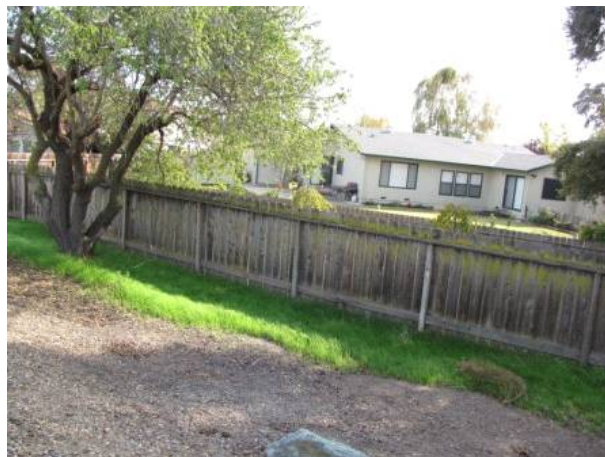
Levee Mile Report Line	93
Start Levee Mile	2.38
End Levee Mile	2.40
Location	Land Side
Category	Earthen Levee
Item	Encroachments

View of a fence at the landward toe.

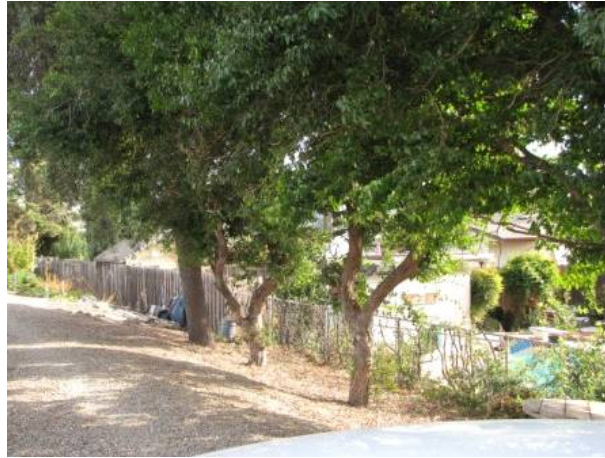
View of a fence at the landward toe.

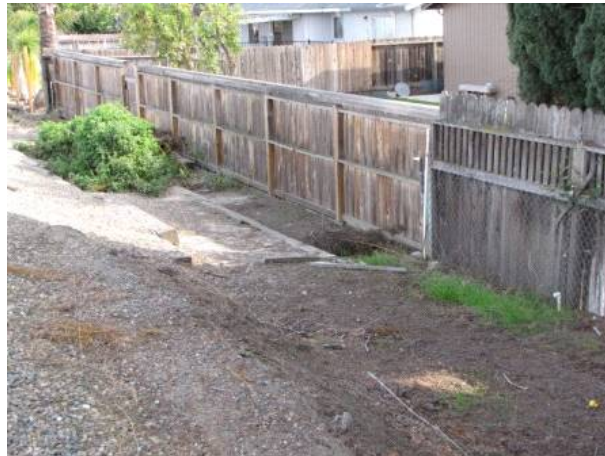
Levee Mile Report Line	95
Start Levee Mile	2.43
End Levee Mile	2.69
Location	Land Side
Category	Earthen Levee
Item	Encroachments

View of a fence at the landward toe looking upstream.

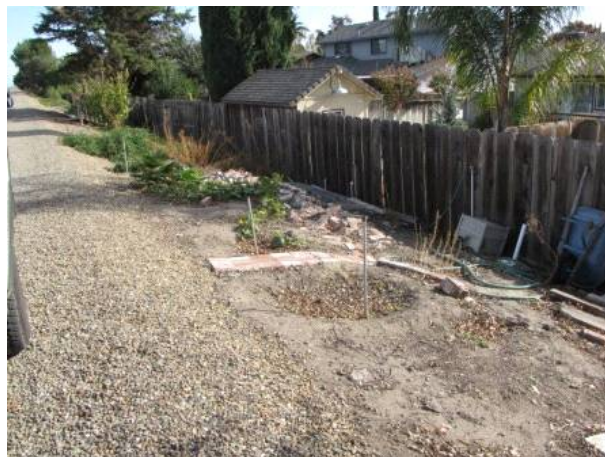
Levee Mile Report Line	96
Start Levee Mile	2.44
End Levee Mile	2.44
Location	Land Side
Category	Earthen Levee
Item	Encroachments

View of debris and landscaping on the landward slope looking upstream.

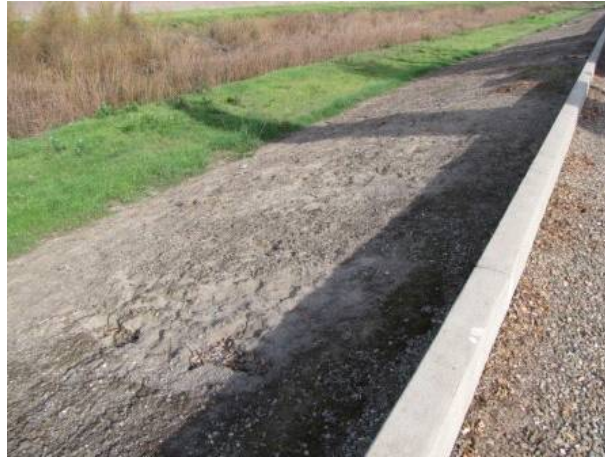
dpesaven_s_20100316_147.jpg

View of erosion occurring on the waterward slope likely due to a landowner pumping water from his pool looking upstream.

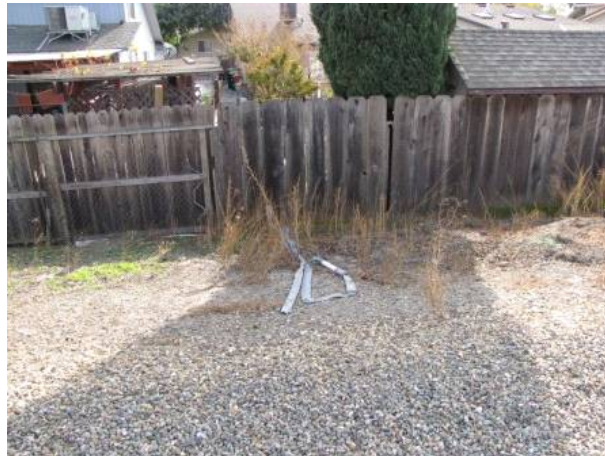
dpesaven_s_20100316_148.jpg

Levee Mile Report Line	97
Start Levee Mile	2.45
End Levee Mile	2.45
Location	Water Side
Category	Earthen Levee
Item	Erosion / Bank Caving

View of the hose likely used to pump the water to the waterward slope.

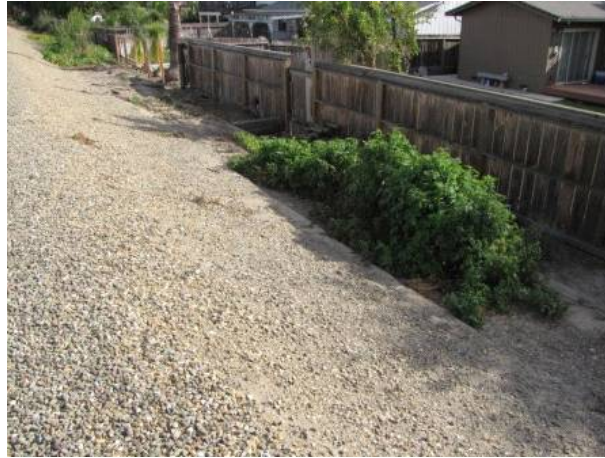
dpesaven_s_20100316_149.jpg

View of vegetable plants and other material on the landward slope and toe.

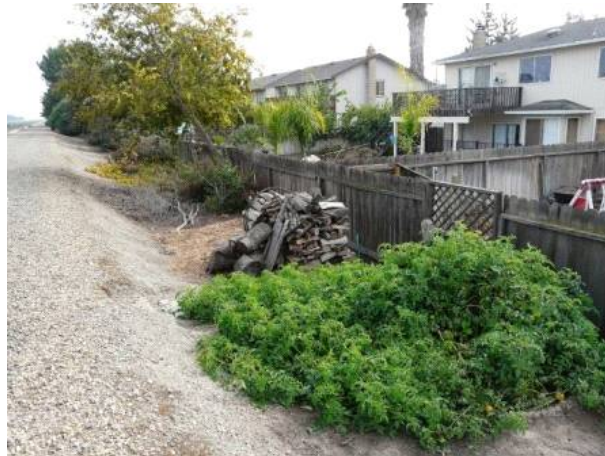
dpesaven_s_20100316_098.JPG

Levee Mile Report Line	100
Start Levee Mile	2.47
End Levee Mile	2.47
Location	Land Side
Category	Earthen Levee
Item	Encroachments

Remove firewood from landside of levee slope at LM 2.47

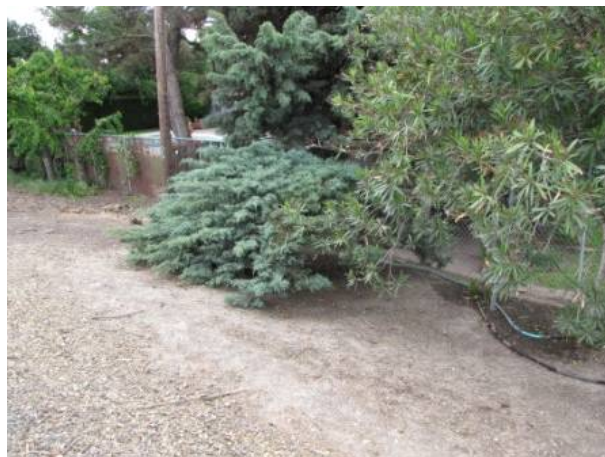
dpesaven_s_20100316_103.jpg

Levee Mile Report Line	101
Start Levee Mile	2.47
End Levee Mile	2.47
Location	Land Side
Category	Earthen Levee
Item	Encroachments

Landscaping along landward slope of levee blocking visibility and access.

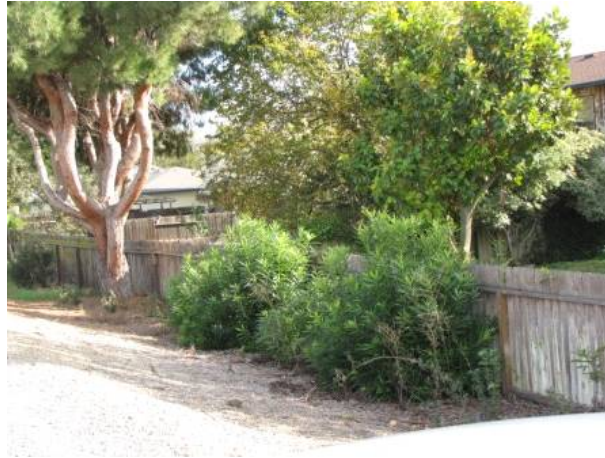
dpesaven_s_20100316_151.jpg

View of landscaping along the landward toe.

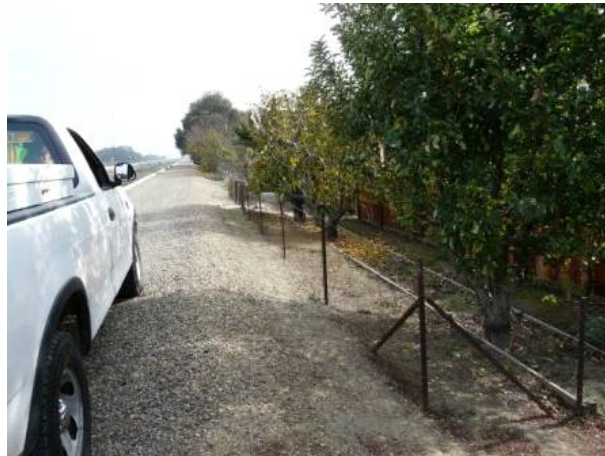
dpesaven_s_20100316_099.JPG

Levee Mile Report Line	105
Start Levee Mile	2.58
End Levee Mile	2.61
Location	Land Side
Category	Earthen Levee
Item	Encroachments

Fence located on sholder of landside of levee from LM 2.58 to LM 2.61

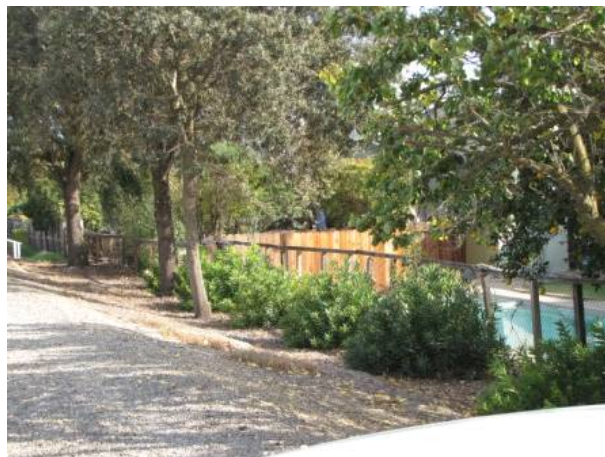
dpesaven_s_20100316_152.jpg

Levee Mile Report Line	106
Start Levee Mile	2.61
End Levee Mile	2.61
Location	Land Side
Category	Earthen Levee
Item	Encroachments

View of landscaping along the landward slope.

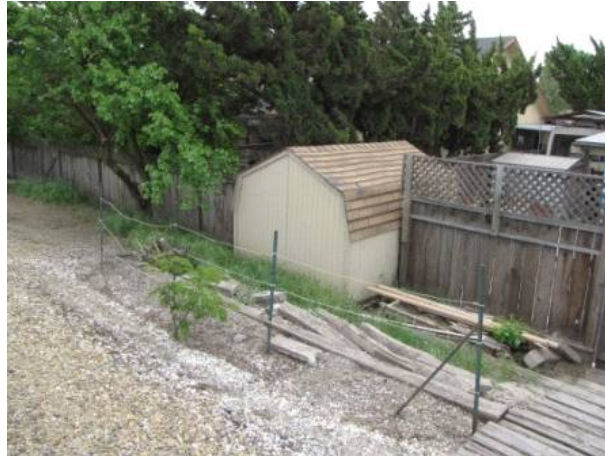
dpesaven_s_20100316_104.jpg

Landscaping and shed placed on landward levee slope and within 10' of the toe.

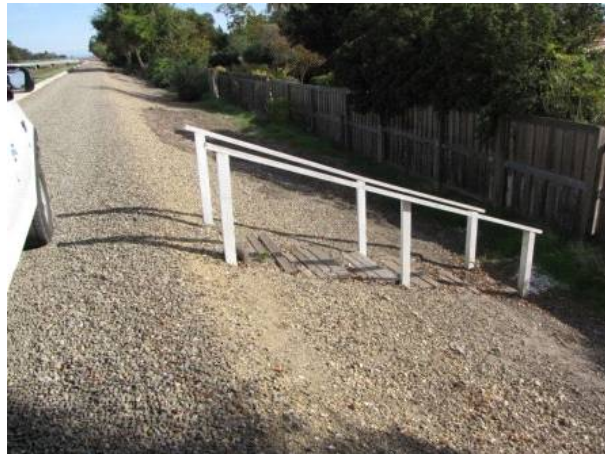
dpesaven_s_20100316_153.jpg

Levee Mile Report Line	108
Start Levee Mile	2.66
End Levee Mile	2.66
Location	Land Side
Category	Earthen Levee
Item	Encroachments

View of steps dug into the landward slope looking upstream.

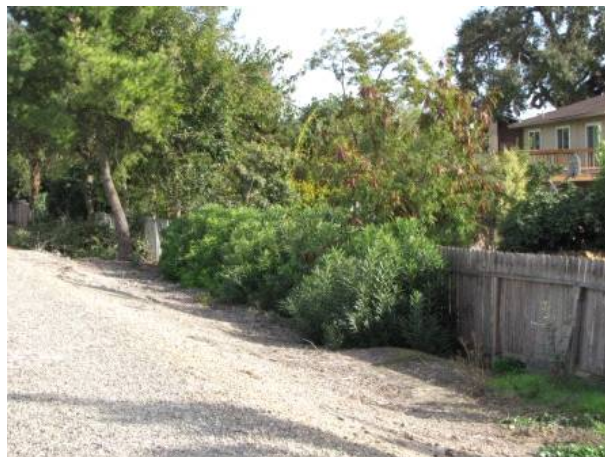
dpesaven_s_20100316_154.jpg

Levee Mile Report Line	109
Start Levee Mile	2.68
End Levee Mile	2.68
Location	Land Side
Category	Earthen Levee
Item	Encroachments

View of landscaping along the landward toe looking upstream.

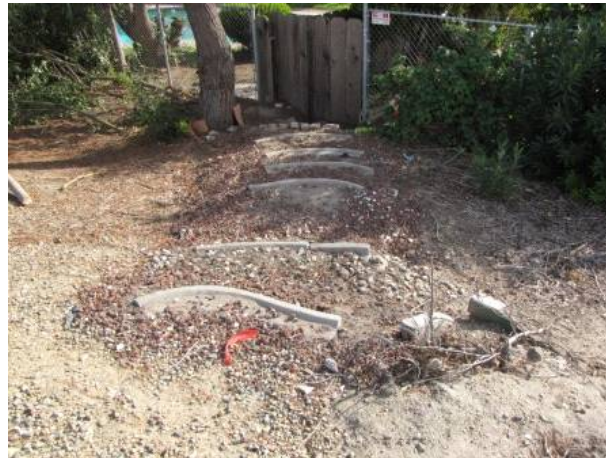
dpesaven_s_20100316_156.jpg

View of steps dug into the landward slope looking upstream.

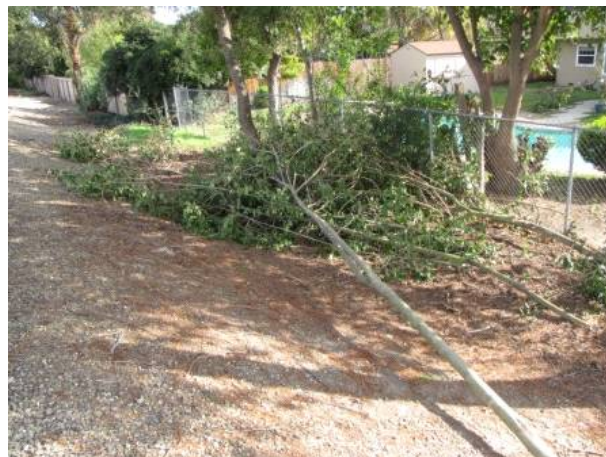
dpesaven_s_20100316_155.jpg

Levee Mile Report Line	112
Start Levee Mile	2.70
End Levee Mile	2.70
Location	Land Side
Category	Earthen Levee
Item	Encroachments

View of prunings on the landward slope and toe looking upstream.

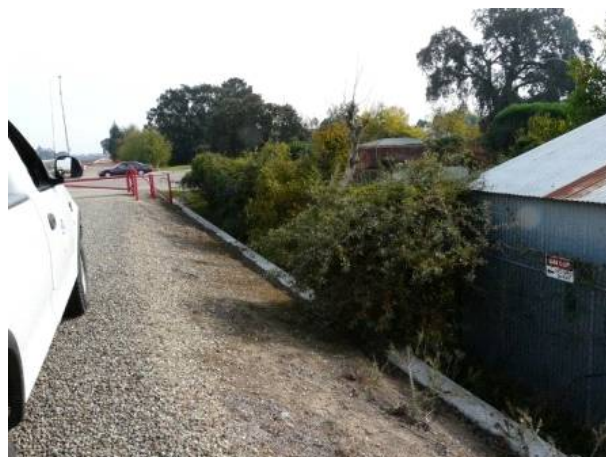
dpesaven_s_20100316_100.JPG

Levee Mile Report Line	118
Start Levee Mile	2.87
End Levee Mile	2.89
Location	Land Side
Category	Earthen Levee
Item	Encroachments

Landscaping along landside toe of levee from LM 2.87 to LM 2.89

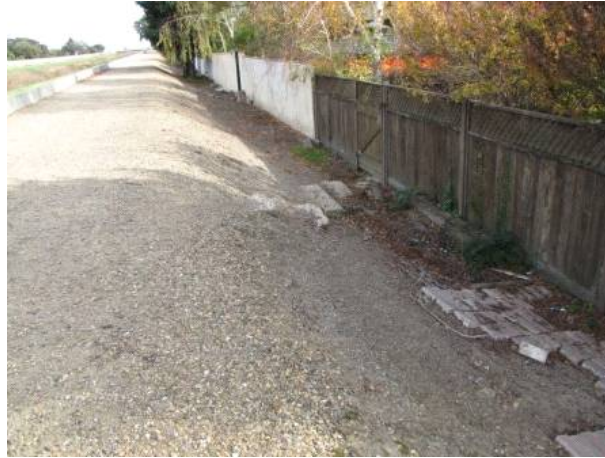
dpesaven_s_20100316_158.jpg

View of steps dug into the landward slope looking upstream.

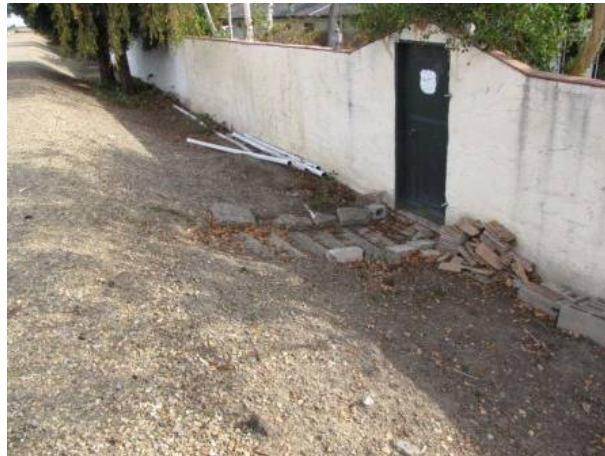
dpesaven_s_20100316_159.jpg

Levee Mile Report Line	123
Start Levee Mile	2.98
End Levee Mile	2.98
Location	Land Side
Category	Earthen Levee
Item	Encroachments

View of steps dug into the landward slope looking upstream.

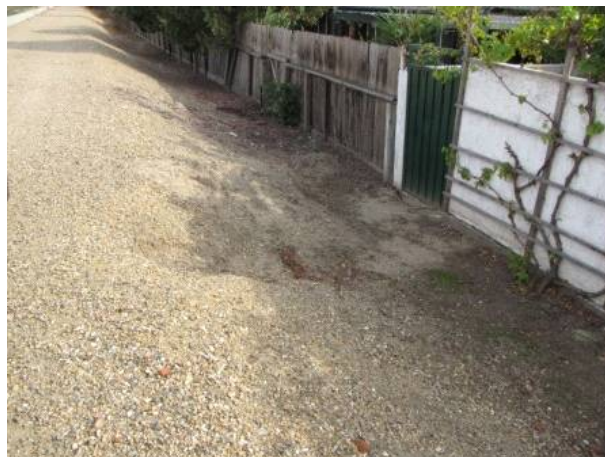
dpesaven_s_20100316_160.jpg

Levee Mile Report Line	124
Start Levee Mile	3.00
End Levee Mile	3.00
Location	Land Side
Category	Earthen Levee
Item	Encroachments

View of steps dug into the landward slope looking upstream.

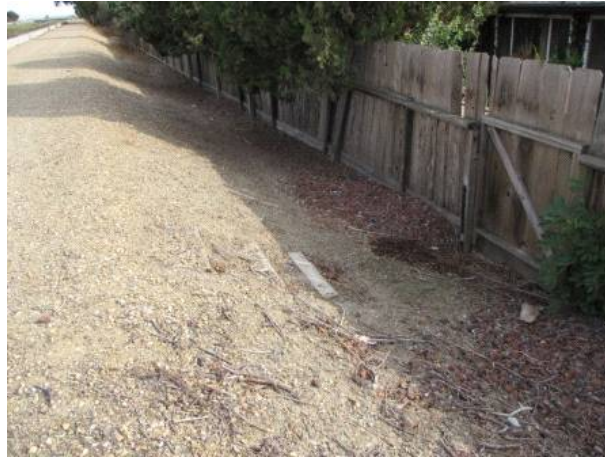
dpesaven_s_20100316_161.jpg

View of steps dug into the landward slope looking upstream.

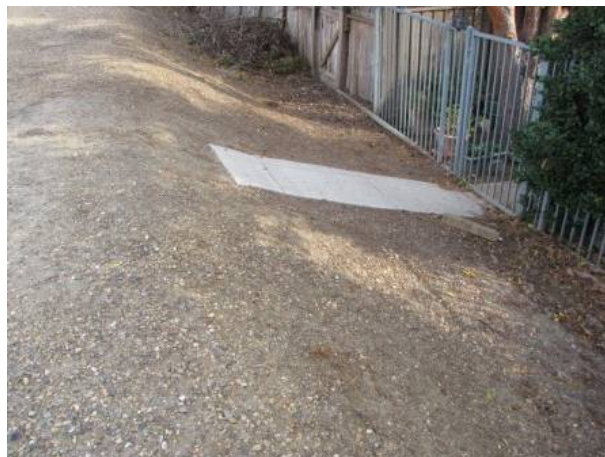
dpesaven_s_20100316_164.jpg

View of a concrete ramp poured into the landward slope. Some damage caused by foot traffic can be seen at the landward shoulder.

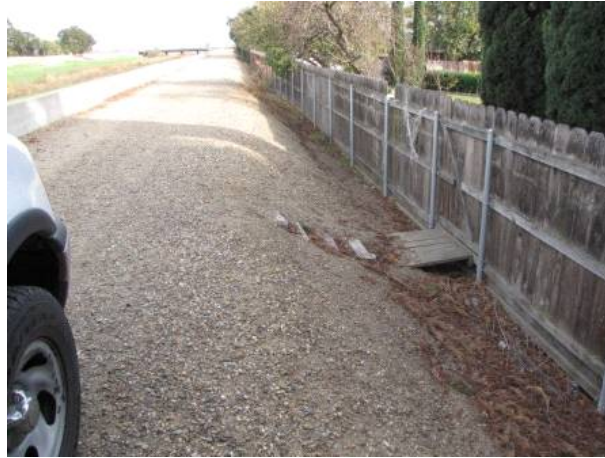
dpesaven_s_20100316_166.jpg

View of steps dug into the landward slope looking upstream.

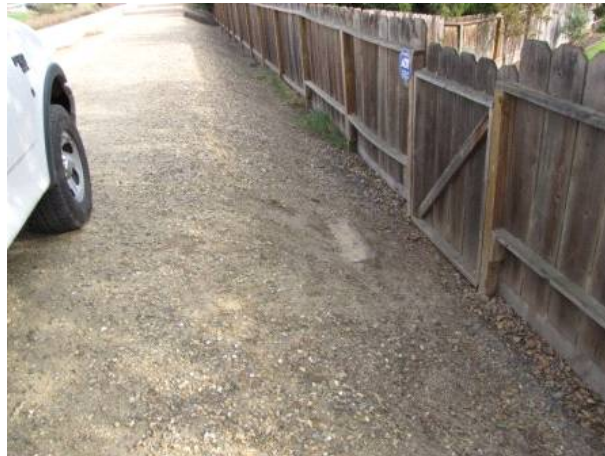
dpesaven_s_20100316_167.jpg

Levee Mile Report Line	131
Start Levee Mile	3.34
End Levee Mile	3.34
Location	Land Side
Category	Earthen Levee
Item	Encroachments

View of steps dug into the landward slope looking upstream.

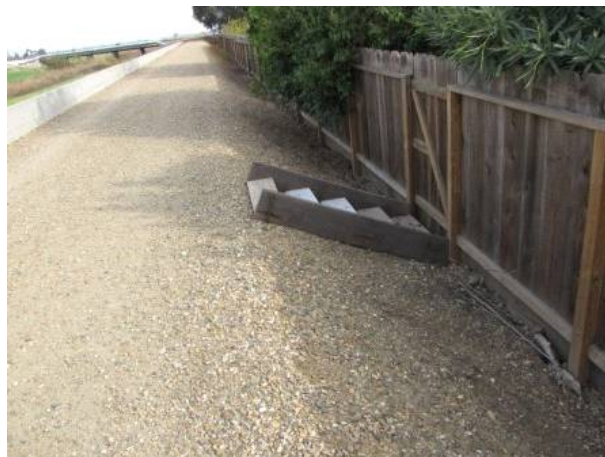
dpesaven_s_20100316_168.jpg

Levee Mile Report Line	132
Start Levee Mile	3.35
End Levee Mile	3.35
Location	Land Side
Category	Earthen Levee
Item	Encroachments

View of steps dug into the landward slope looking upstream.

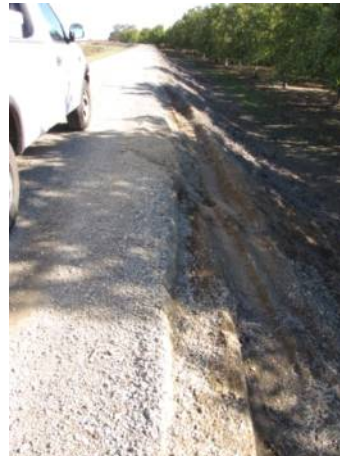
dpesaven_s_20100316_216.jpg

View of the landward slope damaged by vehicular traffic looking upstream.

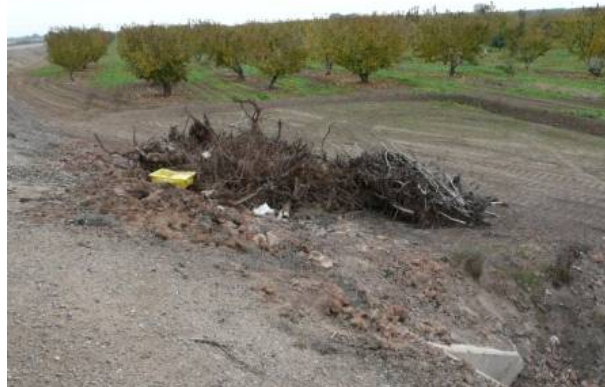
dpesaven_s_20100316_102.JPG

Levee Mile Report Line	152
Start Levee Mile	9.52
End Levee Mile	9.52
Location	Land Side
Category	Earthen Levee
Item	Encroachments

Remove prunings from landside of levee at LM 9.52

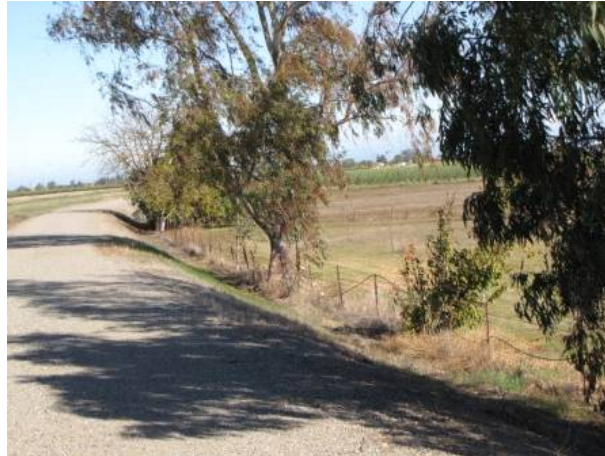
dpesaven_s_20100316_222.jpg

View of a fence at the landward toe looking upstream.

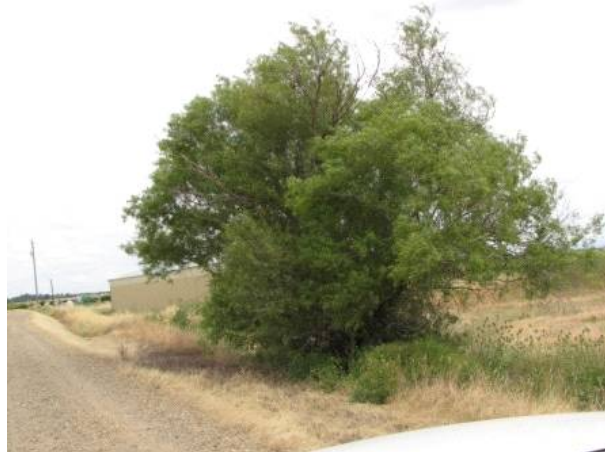
dpesaven_s_20100526_634.jpg

Levee Mile Report Line	173
Start Levee Mile	13.16
End Levee Mile	13.16
Location	Land Side
Category	Earthen Levee
Item	Trim / Thin Trees

View of a tree blocking visibility on the landward slope looking upstream.

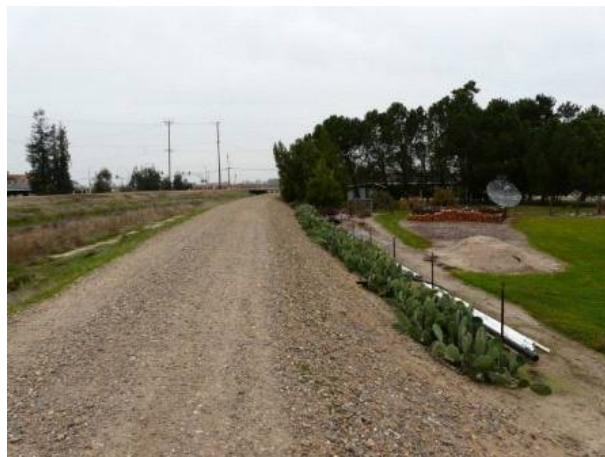
dpesaven_s_20100316_095.JPG

Levee Mile Report Line	174
Start Levee Mile	13.51
End Levee Mile	13.59
Location	Land Side
Category	Earthen Levee
Item	Encroachments

Landscaping along landside of levee from LM 13.51 to LM 13.59. Trim trees along landside of levee slope to allow for visibility from LM 13.54 to 13.59.

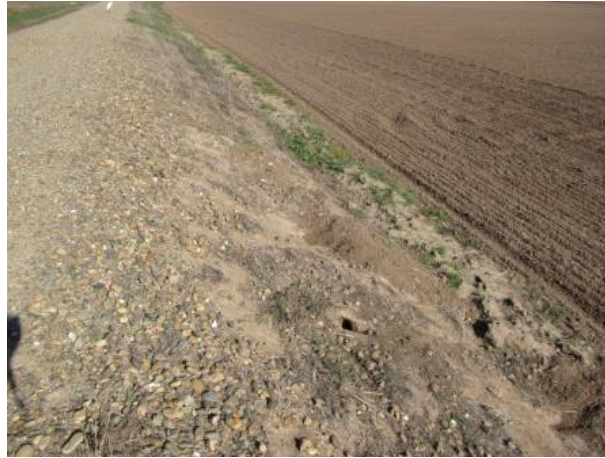
dpesaven_s_20100316_226.jpg

View of rodent activity on landward slope looking upstream.

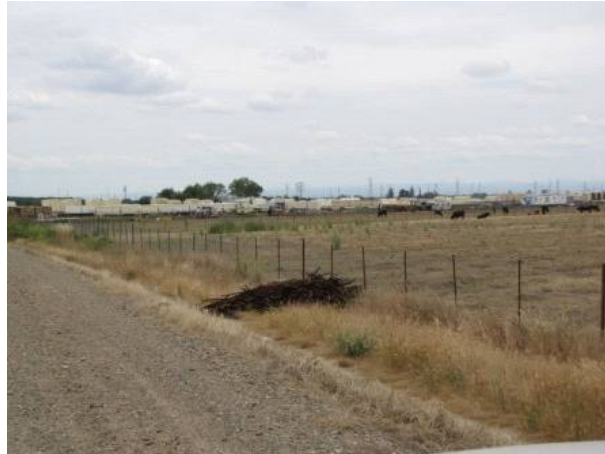
dpesaven_s_20100526_635.jpg

Levee Mile Report Line	180
Start Levee Mile	14.12
End Levee Mile	14.12
Location	Land Side
Category	Earthen Levee
Item	Encroachments

View of debris at the landward toe looking upstream.

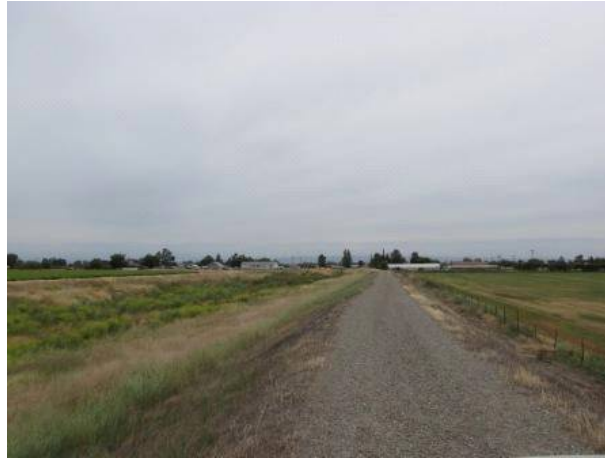
dpesaven_s_20100521_615.jpg

View of the levee looking upstream.

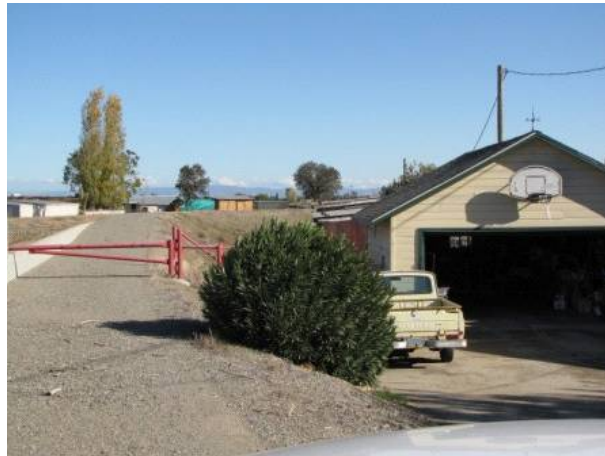
dpesaven_s_20100316_229.jpg

Levee Mile Report Line	4
Start Levee Mile	0.57
End Levee Mile	0.57
Location	Land Side
Category	Earthen Levee
Item	Encroachments

View of an oleander bush maintained by the landowner obstructing visibility and access looking upstream.

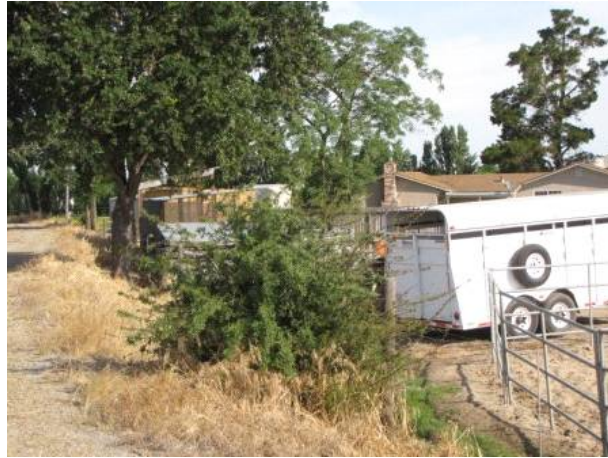
dpesaven_s_20100526_617.jpg

View of a tree blocking visibility on the landward slope looking downstream.

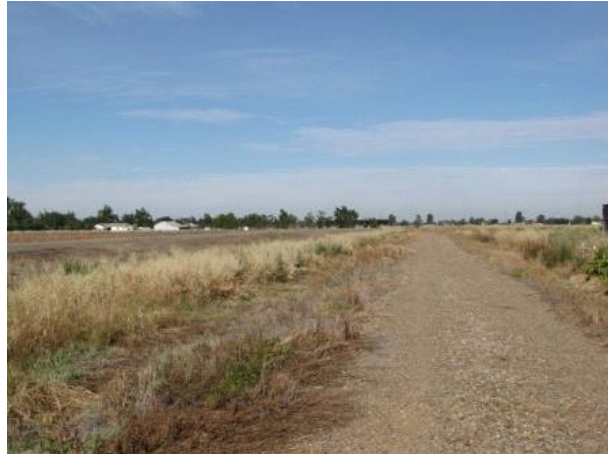
dpesaven_s_20100526_616.jpg

Levee Mile Report Line	5
Start Levee Mile	0.59
End Levee Mile	1.32
Location	Water Side
Category	Earthen Levee
Item	Vegetation

View of vegetation on waterward slope looking downstream.

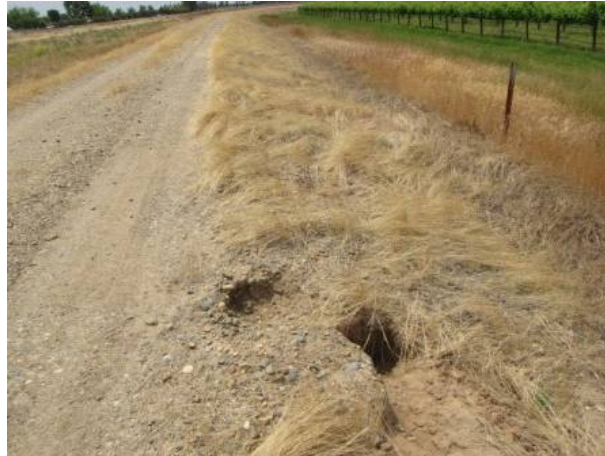
dpesaven_s_20100526_633.jpg

View of rodent holes in the landward slope looking downstream.

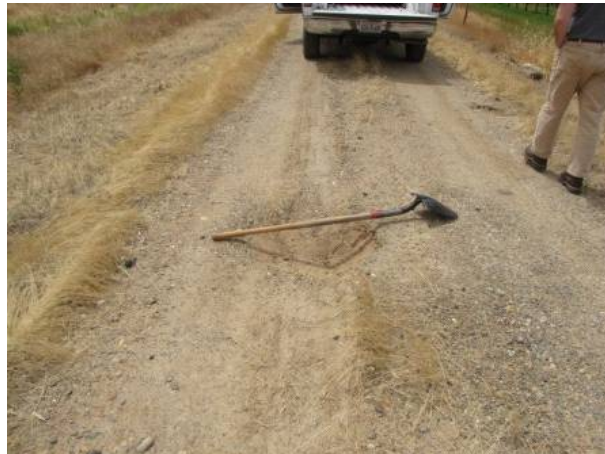
dpesaven_s_20100526_632.jpg

Levee Mile Report Line	3
Start Levee Mile	0.12
End Levee Mile	0.12
Location	Crown
Category	Earthen Levee
Item	Crown Surface / Depressions / Rutting

View of a depression in the crown with a depth of greater than 6 inches looking downstream.

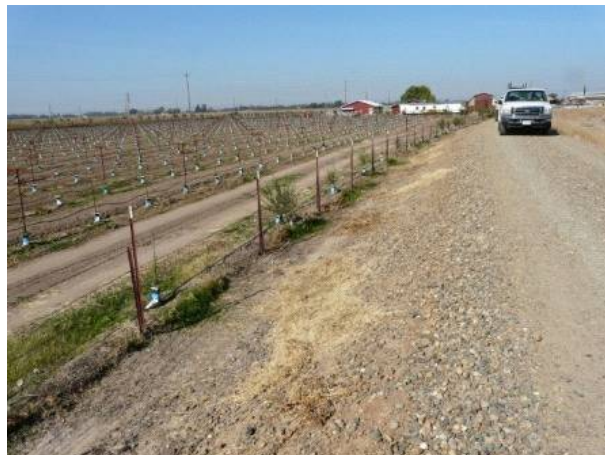
dpesaven_s_20100316_230.JPG

Levee Mile Report Line	4
Start Levee Mile	0.17
End Levee Mile	0.49
Location	Land Side
Category	Earthen Levee
Item	Encroachments

Fence located from LM 0.17 to LM 0.49 and crops located from LM 0.17 to LM 0.41 within 10' from landside toe of levee.

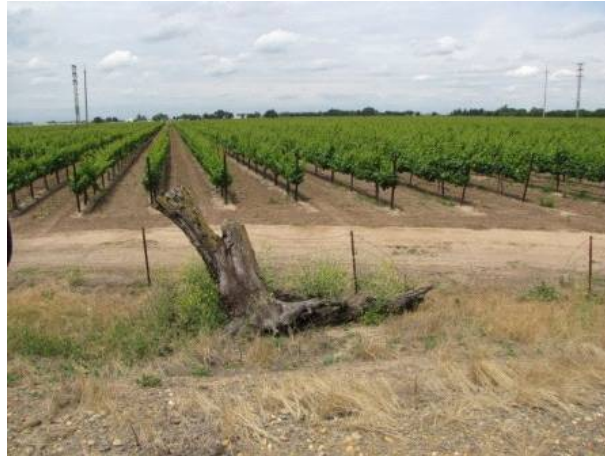
dpesaven_s_20100526_631.jpg

View of a tree stump on the landward slope.

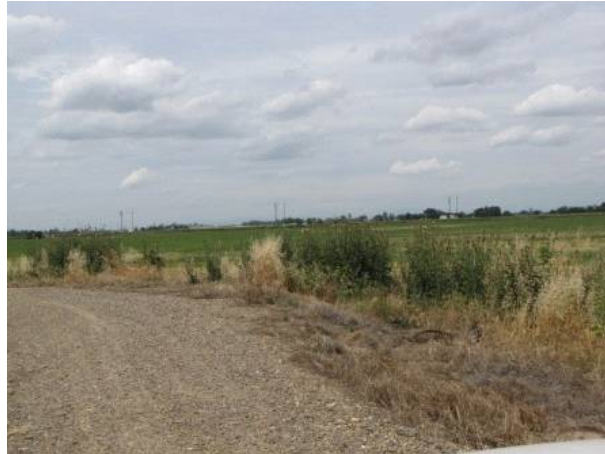
dpesaven_s_20100526_630.jpg

Levee Mile Report Line	13
Start Levee Mile	1.49
End Levee Mile	2.06
Location	Land Side
Category	Earthen Levee
Item	Vegetation

View of vegetation on the landward slope looking downstream.

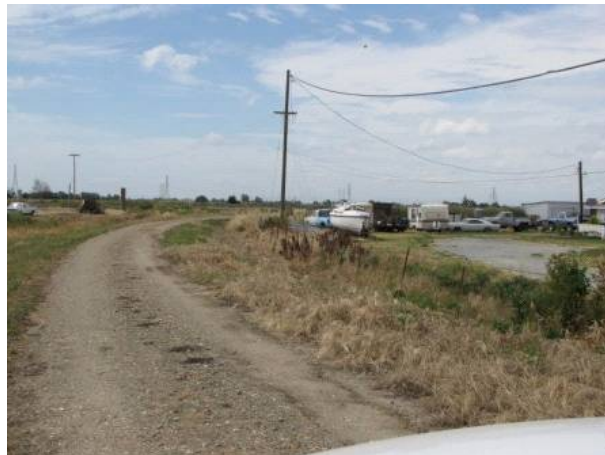
dpesaven_s_20100526_629.jpg

Levee Mile Report Line	17
Start Levee Mile	2.98
End Levee Mile	3.55
Location	Land Side
Category	Earthen Levee
Item	Vegetation

View of vegetation on the landward slope looking downstream.

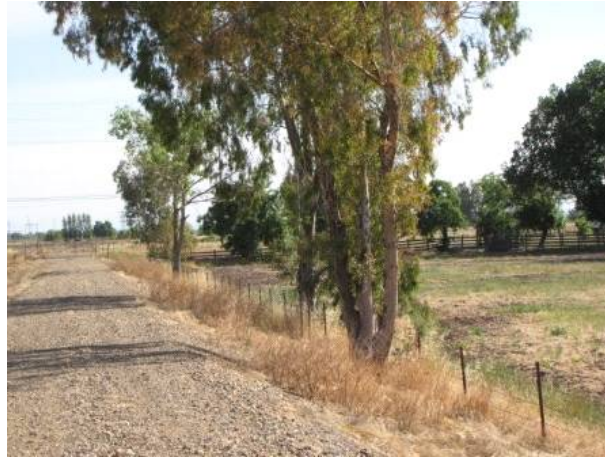
dpesaven_s_20100526_618.jpg

View of vegetation on the landward slope looking upstream.

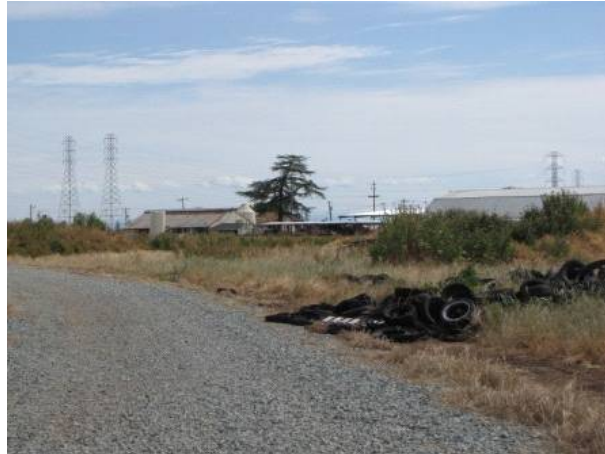
Levee Mile Report Line	10
Start Levee Mile	1.85
End Levee Mile	1.85
Location	Land Side
Category	Earthen Levee
Item	Encroachments

View of tires on the landward portion of the levee looking upstream.

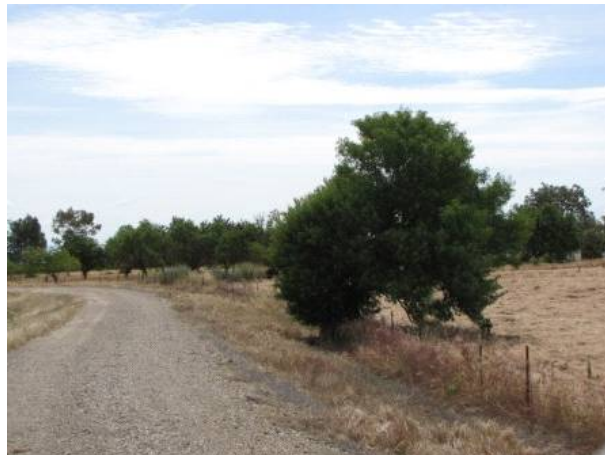
Levee Mile Report Line	15
Start Levee Mile	2.22
End Levee Mile	2.22
Location	Land Side
Category	Earthen Levee
Item	Trim / Thin Trees

View of a tree blocking visibility at the landward toe looking upstream.

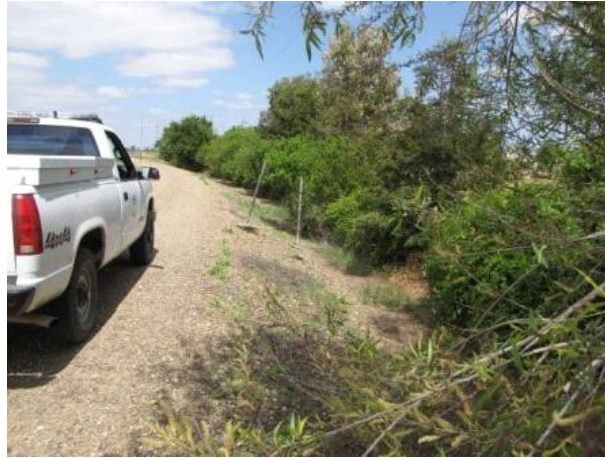
dpesaven_s_20100316_239.jpg

Landscaping on landward levee slope and within 10' of the toe.

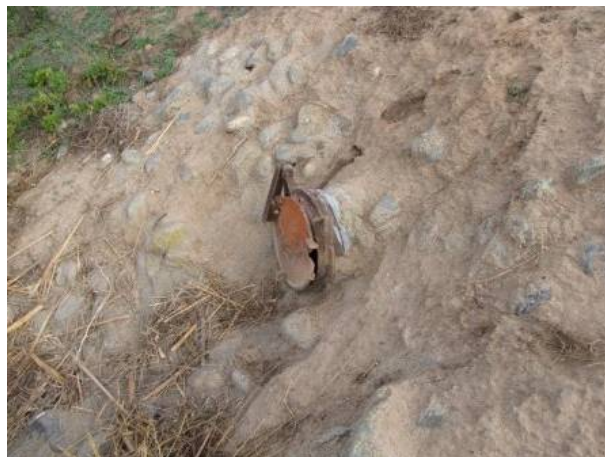
dpesaven_s_20100316_248.jpg

View of a flap gate that has been damaged and is unable to completely close.

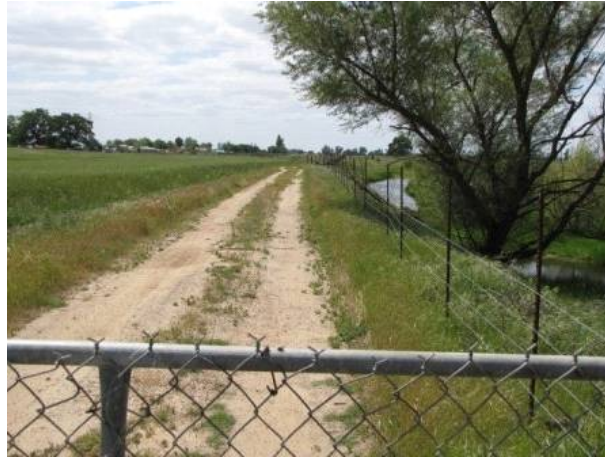
dpesaven_s_20100316_241.jpg

Fence along waterward sholder and crown of access road. The road cannot be driven through as the fence blocks access. The gate does not have a county key on the gate.

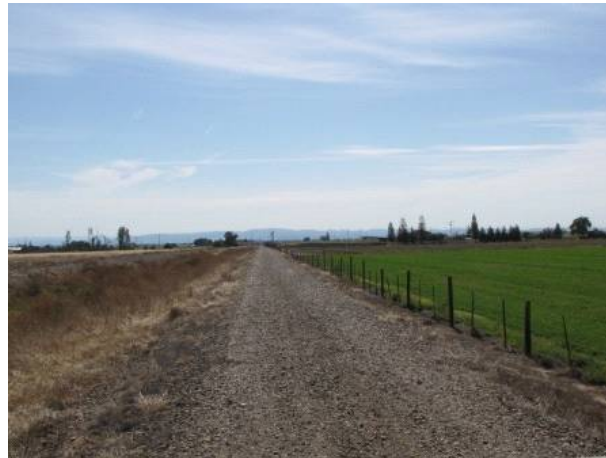
dpesaven_s_20100526_622.jpg

View of vegetation on the landward slope looking upstream.

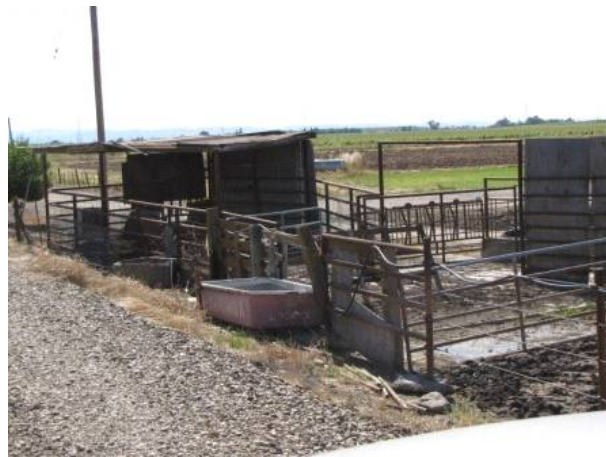
Levee Mile Report Line	2
Start Levee Mile	0.39
End Levee Mile	0.39
Location	Land Side
Category	Earthen Levee
Item	Encroachments

View of a tub/tank on the landward slope blocking access and visibility looking upstream.

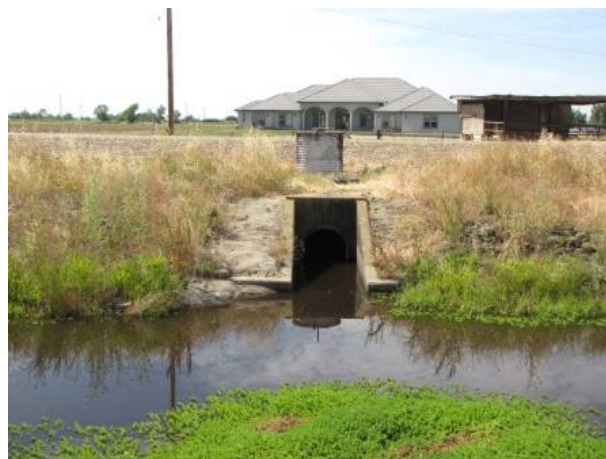
Levee Mile Report Line	3
Start Levee Mile	0.40
End Levee Mile	0.40
Location	Water Side
Category	Interior Drainage & Piping Systems
Item	Flap Gates

View of a outfall pipe with a missing flap gate looking from across the channel.

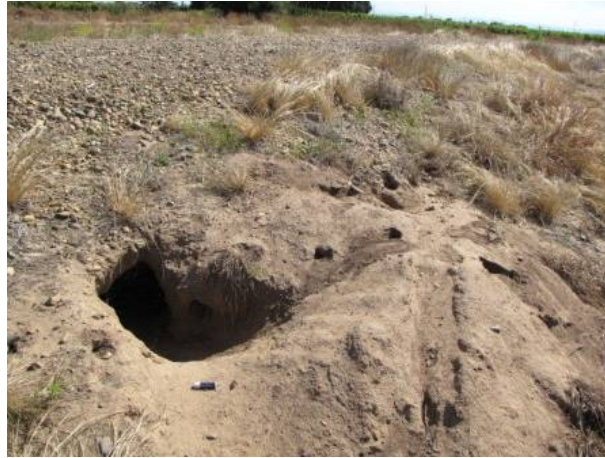
dpesaven_s_20100526_624.jpg

View of a large hole in the landward slope of the levee looking upstream.

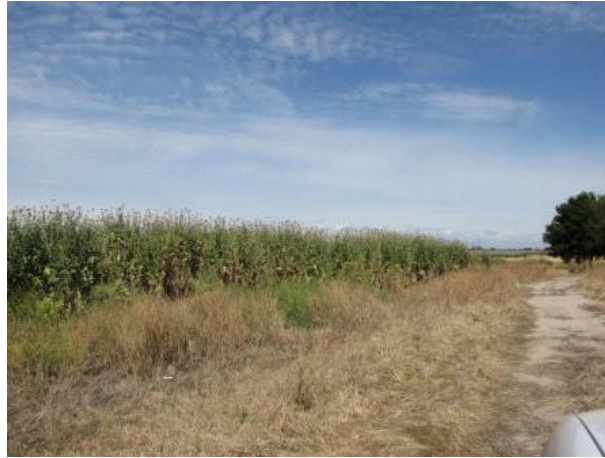
dpesaven_s_20100526_627.jpg

View of tall vegetation on the waterward slope blocking access and visibility looking downstream.

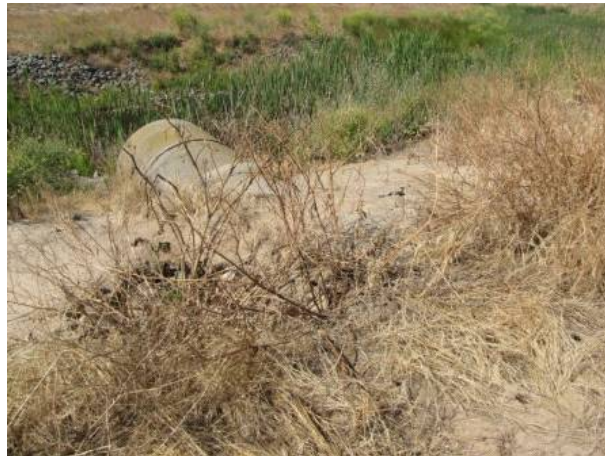
Levee Mile Report Line	2
Start Levee Mile	1.17
End Levee Mile	1.17
Location	Water Side
Category	Earthen Levee
Item	Erosion / Bank Caving

View of erosion and concrete apron settlement around the outfall pipe looking toward the channel and downstream.

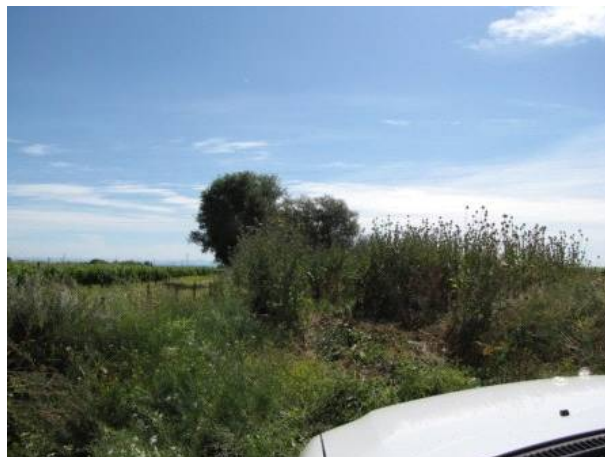
Levee Mile Report Line	3
Start Levee Mile	1.31
End Levee Mile	1.40
Location	Crown
Category	Earthen Levee
Item	Vegetation

View of very dense and tall vegetation blocking access and visibility looking upstream.

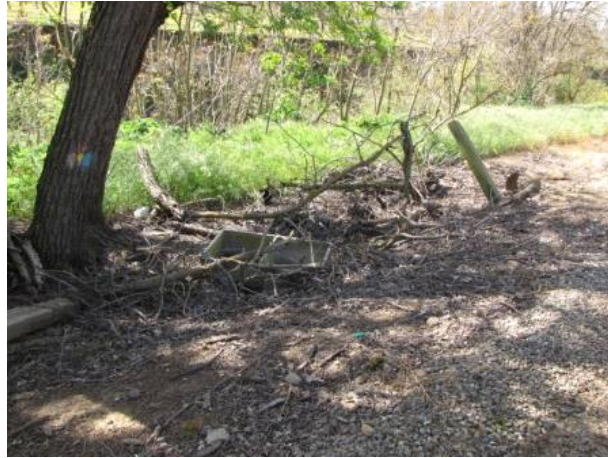
dpesaven_s_20100518_571.jpg

View of branches and debris on the waterward slope looking downstream.

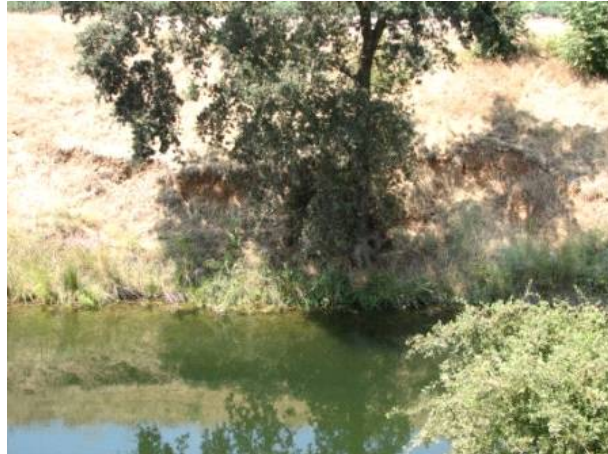
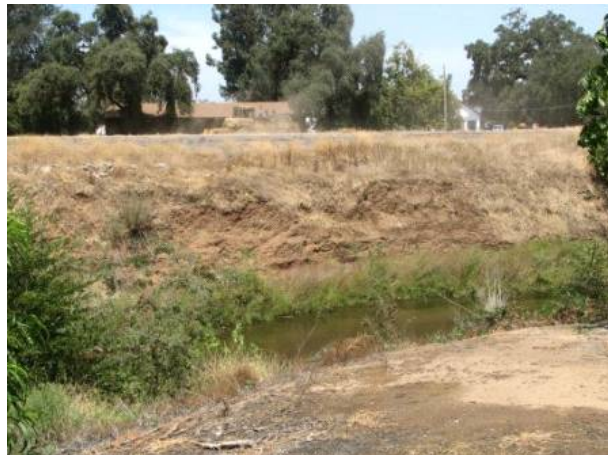
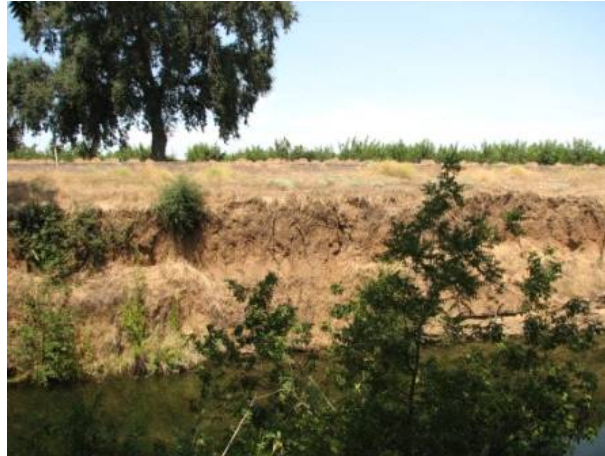
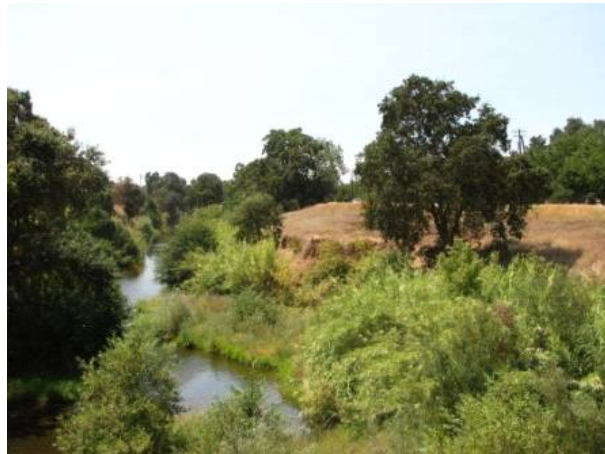
Levee Mile Report Line	2
Start Levee Mile	0.41
End Levee Mile	1.32
Location	Water Side
Category	Supplemental
Item	DWR Erosion Survey

2009: Near-vertical bank erosion; degrading channel is incising the banks; recommend annual assessment and monitoring of critical erosion site, per CLRO CES Evaluation 2008 Report; LMA is monitoring site for changes in condition; previously rated "U" [2009 SiteID:NA0017U15RM0.86]
